**WINDSOR LAKE DAM
MA 00281**

**HUDSON RIVER BASIN
NORTH ADAMS, MASSACHUSETTS**

**PHASE 1 INSPECTION REPORT
NATIONAL DAM INSPECTION PROGRAM**

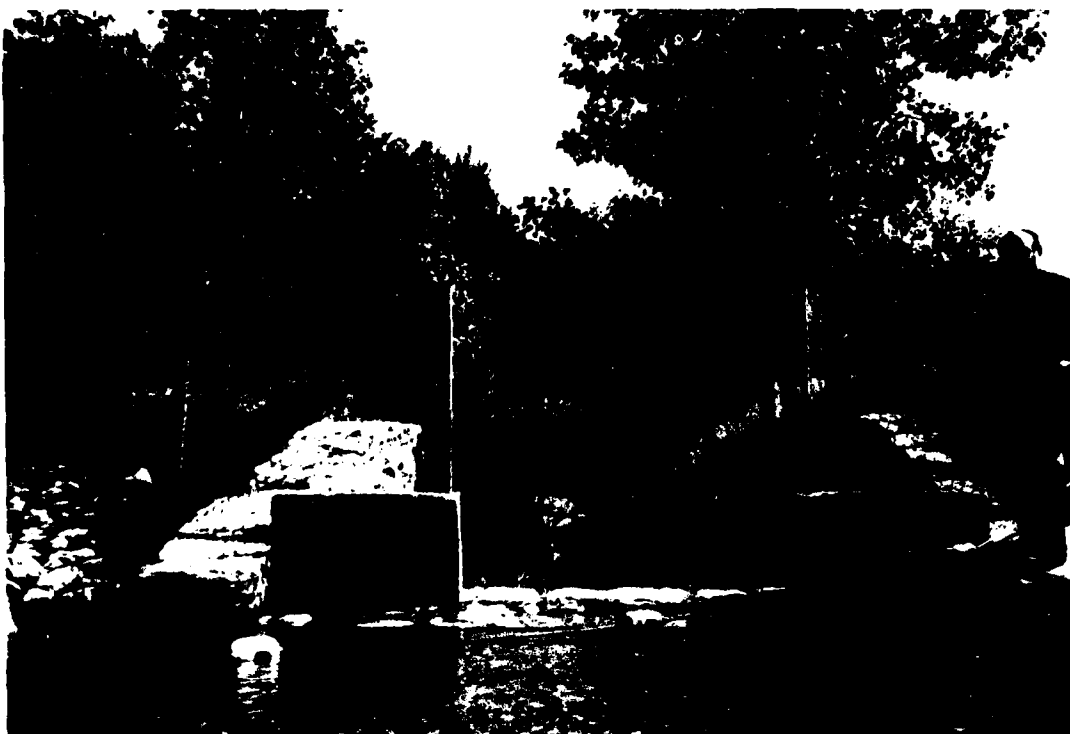
The stone masonry and concrete spillway is in fair condition with loose and missing mortar in the joints and displacement of some of the masonry on the weir. The stone floor of the structure is covered with silt and vegetation. Several of the stones have been displaced especially in the area around the edge and front of the sill. (See Photograph Nos. 5 & 6)

⑤ SPILLWAY LOOKING DOWNSTREAM
NOTE RIPRAP ON UPSTREAM SLOPE

7. Masonry training walls of the spillway should be repaired.

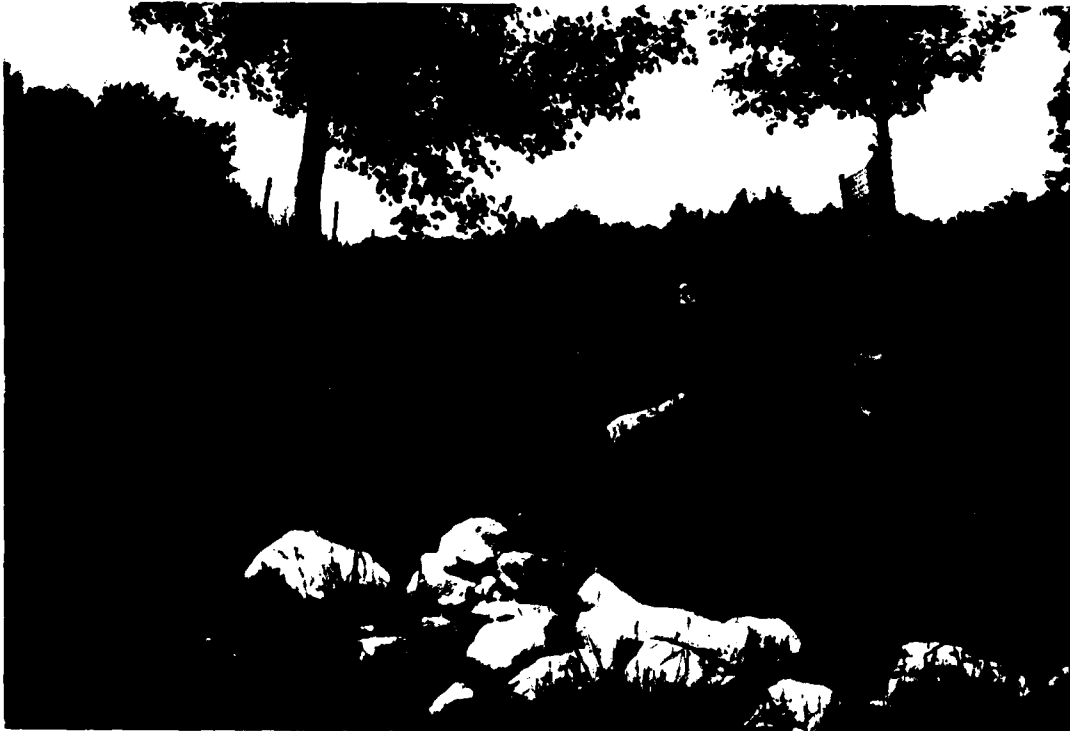
⑦ VIEW OF SPILLWAY CHANNEL LOOKING UPSTREAM
NOTE STONES IN FOREGROUND FOR DIVERSION OF CHANNEL
